EARLY NEW MEXICO MILITARY FORTS

NEW MEXICO MILITARY FORTS, 1870s

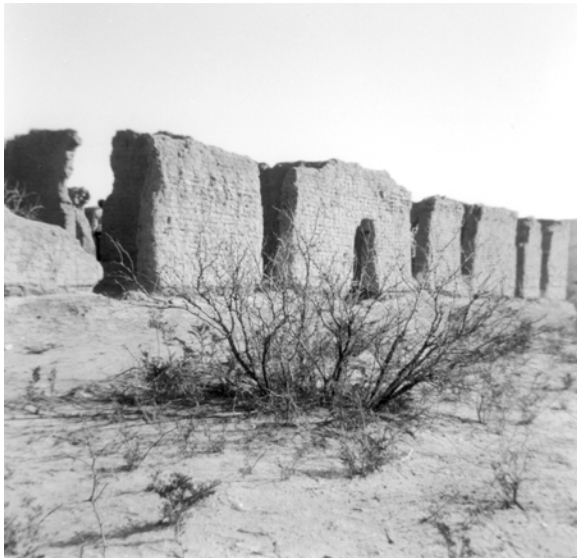
Figure A5.16. Fort Selden adobe ruins, photographed March 1955 by William H. Farrington, Jr. Courtesy of Museum of New Mexico, Negative No. 1803.

The fort site was patented to Felipe Duran in March 1909. Six months later Duran sold the southwest quarter of the northwest quarter of Section 14, Township 21, and part of Section 11 to Charles Cole, who held it for six months before selling to Ida M. Llewellyn. Llewellyn kept the property for four years, until November 13, 1914, when she sold to the Fort Selden Hot Springs International Spa and Improvement Company (List of Fort Selden Owners, in miscellaneous research file, Fort Selden permanent files, NMSM), which planned to capitalize on the nearby Radium Springs as a health resort; however, the company failed almost immediately. About the same time, a Fort Selden home site was platted (Cohrs and Caperton 1983:28). On May 3, 1921, the Fort Selden Hot Springs Resort, National Spa and Improvement Company sold the property to Francis L. Lewellyn. On September 9, 1944, Harry H. Bailey acquired the Fort Selden ruins from E. E. and Helen McIntyre (List of Fort Selden Owners, in miscellaneous research file, Fort Selden permanent files, NMSM; see Figure A5.16).

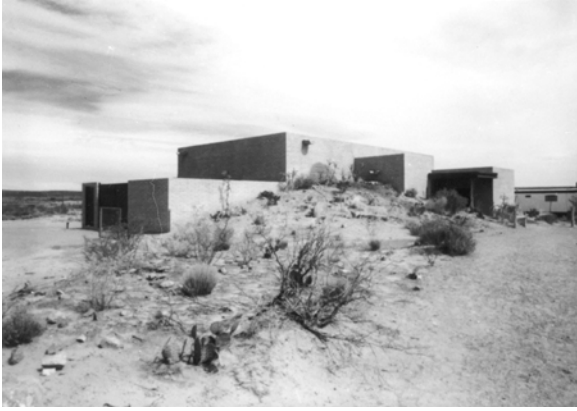
Figure A5.17. Fort Selden State Monument visitor center, photographed by David Sullenberger, March 1976. Courtesy of Museum of New Mexico, Negative No. 67545.

In late February 1974 Caperton reported construction of the visitor center (Figure A5.17) was progressing well. Completion was scheduled for March 22 though Caperton thought they might finish early. The exhibit designer was completing his work, and the exhibits should be installed in the late spring. Also, Chan Graham had asked Caperton for a recommendation to the State Planning Office for consideration for future consultant work. Caperton praised Graham and his work for Fort Selden. “Communication with Chan has been good and he has done an excellent job of contract administration with a sometimes difficult contractor” (Thomas J. Caperton, letter to David W. King, February 27, 1974, Fort Selden correspondence file, HPD).

In June 1975 Caperton sent a list of deficiencies in the visitor center to Carl Sedillo, Property Control Division. The five items listed are: (1) the concrete front and back porch floors extended beyond the porch roofs, which had no rain gutters, and water ran onto the porch floor and into the museum, especially at the front entrance; (2) the building roof leaked in a number of places, partly caused by the placement of the drain spouts; (3) the chimney for ducting on the building's north side was separating from the main entrance; (4) the service yard wall was separating from the main building; and (5) the plywood on the yard gates was coming loose (Thomas J. Caperton, letter to Carl Sedillo, Assistant Chief, Property Control Division, June 25, 1975, copy in outgoing 1974–1975 Fort Selden files, NMSM).

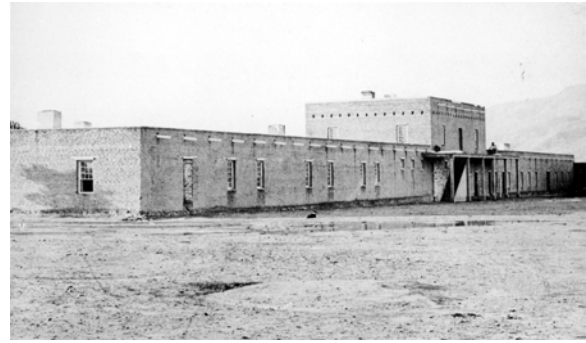
Figure A5.20. Headquarters Building, photographed from the parade ground by Nicholas Brown in July 1867. Courtesy of Museum of New Mexico, Negative No. 55040.

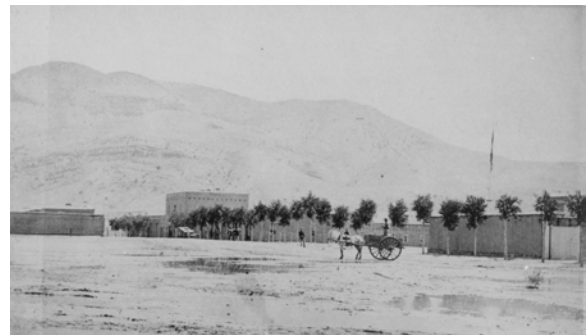
Figure A5.21. View of corrals, Headquarters Building, barracks in distance, and Officers’ Quarter from northeast. Photograph taken by Nicholas Brown in July 1867. Courtesy of Museum of New Mexico, Negative No. 55045.

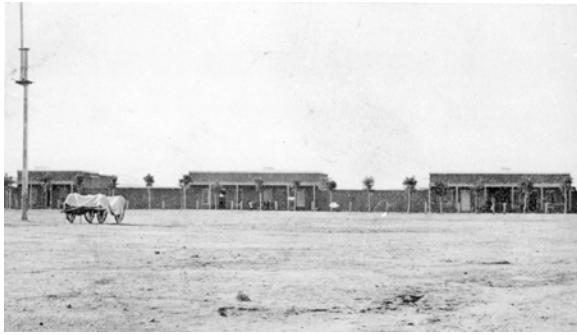
Figure A5.22. The row of officers' quarters at the north end of the parade ground, photographed by Nicholas Brown in July 1867. Courtesy of Museum of New Mexico, Negative No. 1740.

The row of officers' quarters defined the north end of the parade ground (Figure A5.22). The structures were two double houses (Figures A5.23 and A5.24) and one single dwelling, at the west side (Figure A5.25). The plan of the single quarters appears to be the same as the east side of each double quarters. Each individual quarters had a larger room as its front room, with two smaller rooms aligned behind the front room. Each room had a door to the next room and to the outside. Kitchens were said to be in small buildings behind the quarters (Cohrs and Caperton 1983:5). In 1869 the officers' quarters could accommodate five families. The roofs of these buildings were unusual to Fort Selden: they were sawed joists with boards over them (Caperton 1975:59).

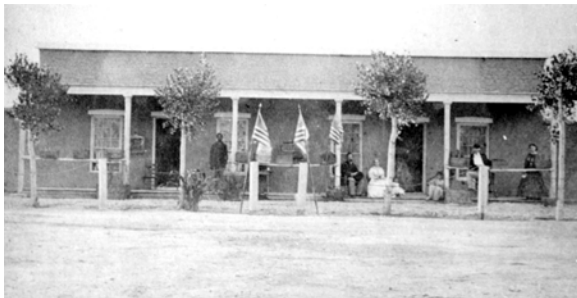
Figure A5.24. Double house in the row of officers' quarters, photographed by Nicholas Brown in July 1867. Courtesy of Museum of New Mexico, Negative No. 55042.

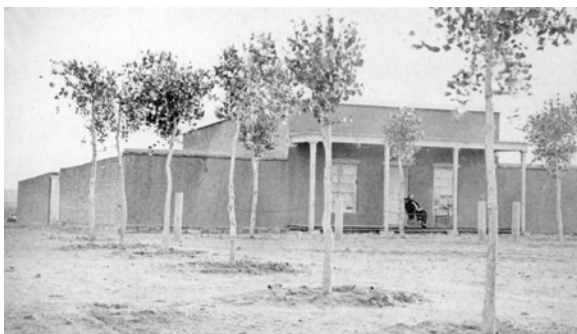
Figure A5.25. The single dwelling at the west side of the row of officers' quarters, photographed by Nicholas Brown in July 1867. Courtesy of Museum of New Mexico, Negative No. 55044. Note the structure and yard wall are stuccoed on the front only.

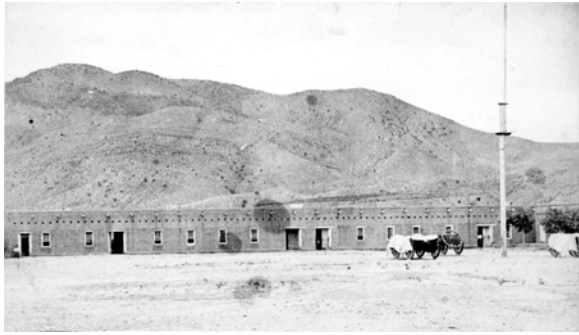
Figure A5.26. Fort Selden's barracks,, photographed by Nicholas Brown in July 1867. Courtesy of Museum of New Mexico, Negative No. 55039.

The front part of this long building was divided into two dormitories, one for each company. On the 1871 plan each dormitory was 85 feet long by 24 feet deep. Each dormitory had four doors, two on the north side and two on the south. Each room had five windows on the north side facing the parade ground and two windows on the south facing a walled courtyard. At the outside ends of the two barracks were two rooms for the sergeants' quarters, which do not open into the dormitories. For some reason, the rooms of the two quarters were different sizes. Both rooms of the east sergeant's quarters were 16 by 11 feet, but the front room on the west quarters was 16 by 13 feet with a 16 by 9 foot room behind it. Both quarters opened into company storerooms immediately behind them on the south. The east storeroom is divided approximately in half, with the company tailor occupying the south half (Figure A5.13). In the 1867 photograph of the front of the barracks (Figure A5.26), the four openings into the dormitories appear to be double doors.

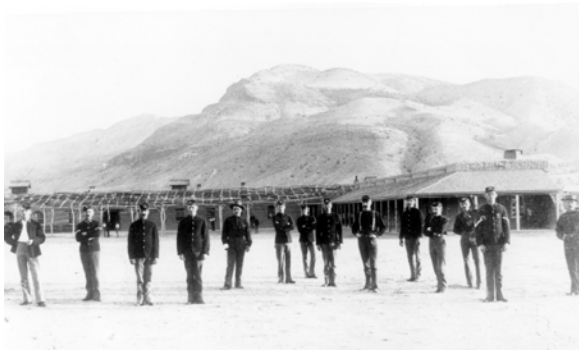
Figure A5.27. Soldiers in front of barracks and hospital to the right, photographed by J. R. Riddle, circa 1886. Courtesy of Museum of New Mexico, Negative No. 14523.

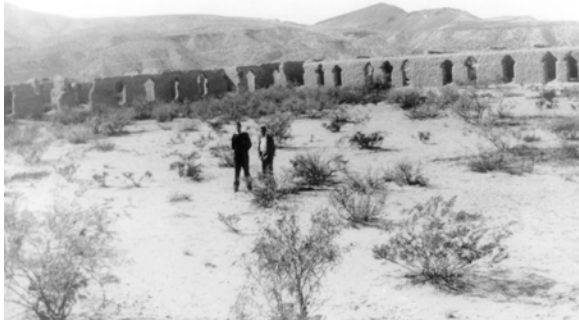
Figure A5.28. This photograph documents the rapid deterioration of the barracks and hospital buildings in the 45 years after the fort was abandoned. Photograph taken in spring 1936. Courtesy of Museum of New Mexico, Negative No. 150956.

October and November, when nearly 24 inches of rain fell in the Mesilla Valley, the men set up tents in their quarters because the roof leaked so badly. The roof was repaired partially in March 1890, and the barracks were painted and whitewashed (Caperton 1975:1, 29, 77). The 1896 survey of Fort Selden Abandoned Military Reservation listed the barracks as 1 of the 17 buildings remaining (Fort Selden Abandoned Military Reservation, Folder #1, typescript in miscellaneous research file, Fort Selden permanent files, NMSM; see Figure A5.28).

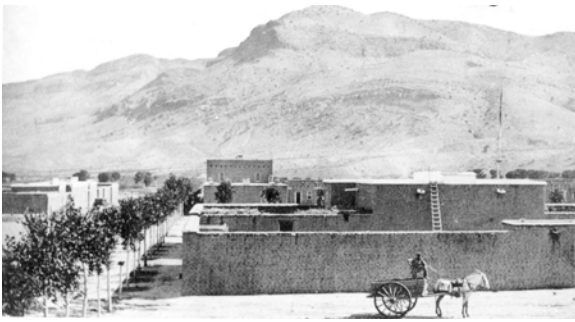
Figure A5.29. This interesting photograph, taken from the north by Nicholas Brown in July 1867, shows the corrals at the left. Courtesy of Museum of New Mexico, Negative No. 1742.
